Manhole Inspection Summary

Manhole # S23C1_027MH

Location Address: **2620 Alaska Ct.**

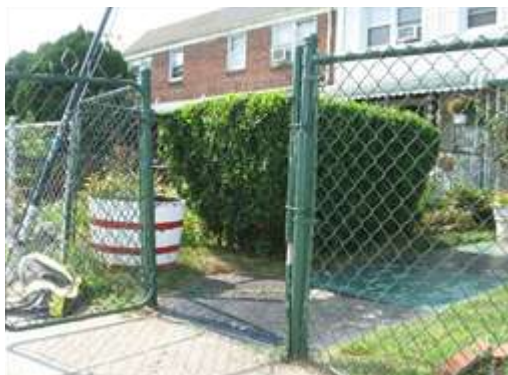
Location View

in front of hedge

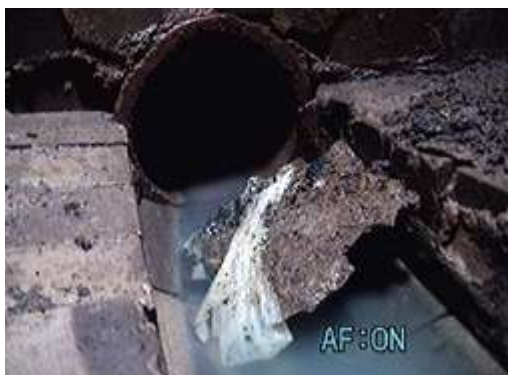
Miscellaneous

Debris in channel

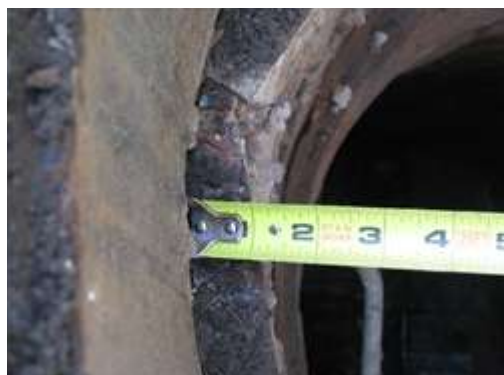
Defect 6

Frame Offset: **1** (in.) Condition: ☒ Sound ☐ Cracked ☐ Leaks

1" offset

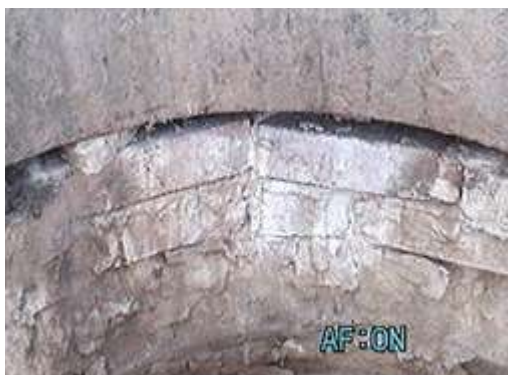
Defect 4

Infiltration: ☐ None ☒ **Joint** ☐ Cracks ☒ **Mortar** ☐ Roots ☐ Wall

Infiltration because of missing mortar

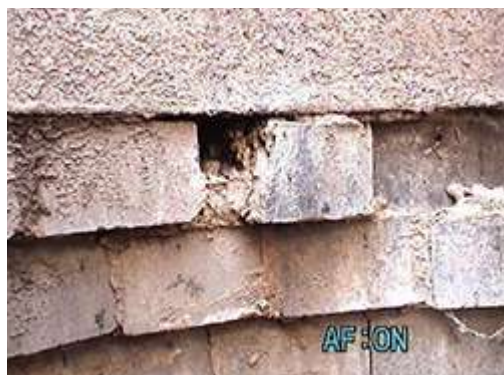
Defect 3

Condition: ☐ Sound ☐ Cracked ☐ Root Intrusion ☐ Loose Brick ☒ **Deteriorated**

chimney deteriorated with flow at joint

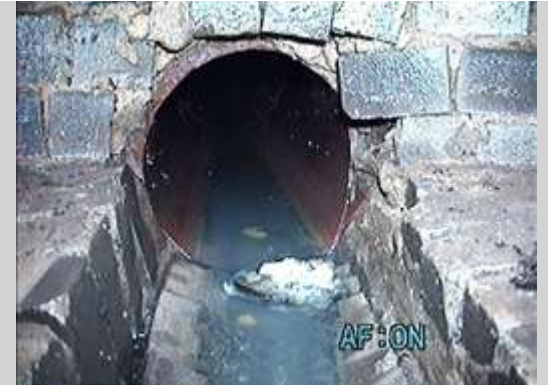
12 O'Clock Outflow

Pipe Height: **8.4** (in.) Rod and Bar (Angled)
Pipe Material: **Clay** ☐ Pipe Lined
Invert Depth: **9.41** (ft.) Flow Characteristics: **Slow**
Deposits: ☒ None ☐ Mud ☐ Sludge ☐ **Debris** ☐ Grease
Silt Depth: **0** (in.) Deposits Extent: **Light**
Infiltration: **None** Pipe Seal Cond: **Sound**

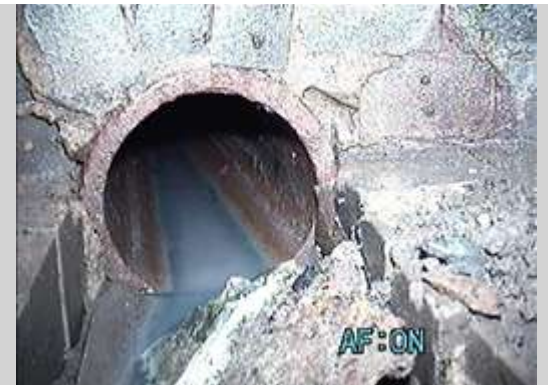
6 O'Clock Inflow

Pipe Height: **6** (in.) Rod and Bar (Angled)
Pipe Material: **Clay** ☐ Pipe Lined
Invert Depth: **9.20** (ft.) Flow Characteristics: **None**
Deposits: ☐ None ☐ Mud ☐ Sludge ☒ **Debris** ☐ Grease
Silt Depth: **1** (in.) Deposits Extent: **Light**
Infiltration: **None** Pipe Seal Cond: **Sound**
